mission possible

Comprehensive restoration with Xive implants, open sinus lift and newly adjusted occlusal plane

| Hans-W. Schellekens

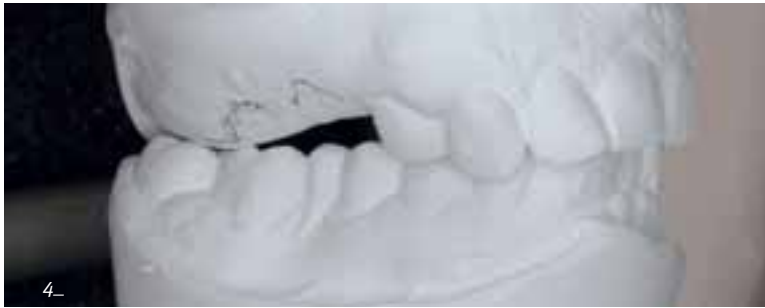
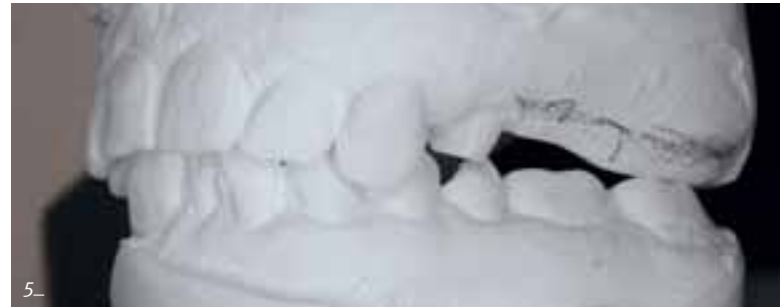
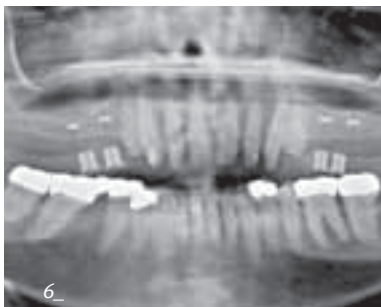
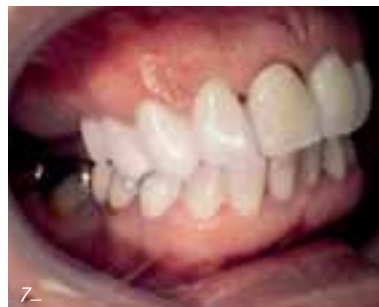
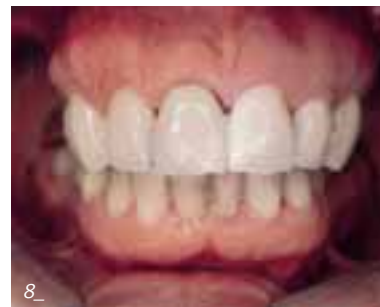
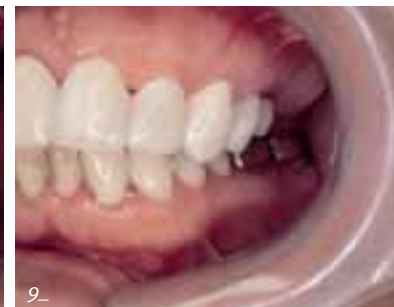
1, 2, 3_The 50-year-old patient was unable to wear her removable prosthesis for eight years. The lack of support resulted in reduction of the occlusal height.
 4, 5_The difficulty involved in a prosthetic restoration was clearly shown in the master cast.
 6_The maxilla was atrophied and in the region of the planned implants the bone volume was only between 5.5 mm and 8.9 mm.
 7, 8, 9_A long-term temporary denture was used to raise the bite and adjust the occlusion.

After an information session at our dental practice on the topic of “bone remodeling and implant placement with unfavorable jaw conditions”, the 50-year-old patient presented for a consultation. Her case history showed that for about eight years she had not worn the upper denture because she could no longer tolerate it. The patient wanted a fixed restoration. According to her information various dentists had unfortunately rejected her desired solution because of the inadequate bone volume and all advised against an implant-supported restoration. She was finally given an interim restoration fixed with wire clamps to raise the bite. The result was an anterior open bite 3 mm high. She wore this restoration without complaint for a full year. The clinical images (Fig. 1 to 3) and the master casts (Fig. 4 and 5) clearly illustrate the situation.

After discussion with the patient, the selected solution was an implant-supported denture for the upper posterior tooth region preceded by bite raising. This would urgently require augmentation in the maxilla (Fig. 6). The patient also agreed to this procedure – a bilateral open sinus lift was planned.

The comprehensive restoration was started with bite raising. In the first step all teeth in the maxilla were prepared. A long-term temporary denture was inserted as an interim solution with a framework of a base-metal alloy veneered with plastic (Fig. 7 to 9). The bite raising procedure required replacement of the second premolars by an extension of the crown block. The main question with such measures is always whether the patient will tolerate the modified occlusal height. Fortunately there were no problems with the patient remaining completely pain-free even after several weeks.

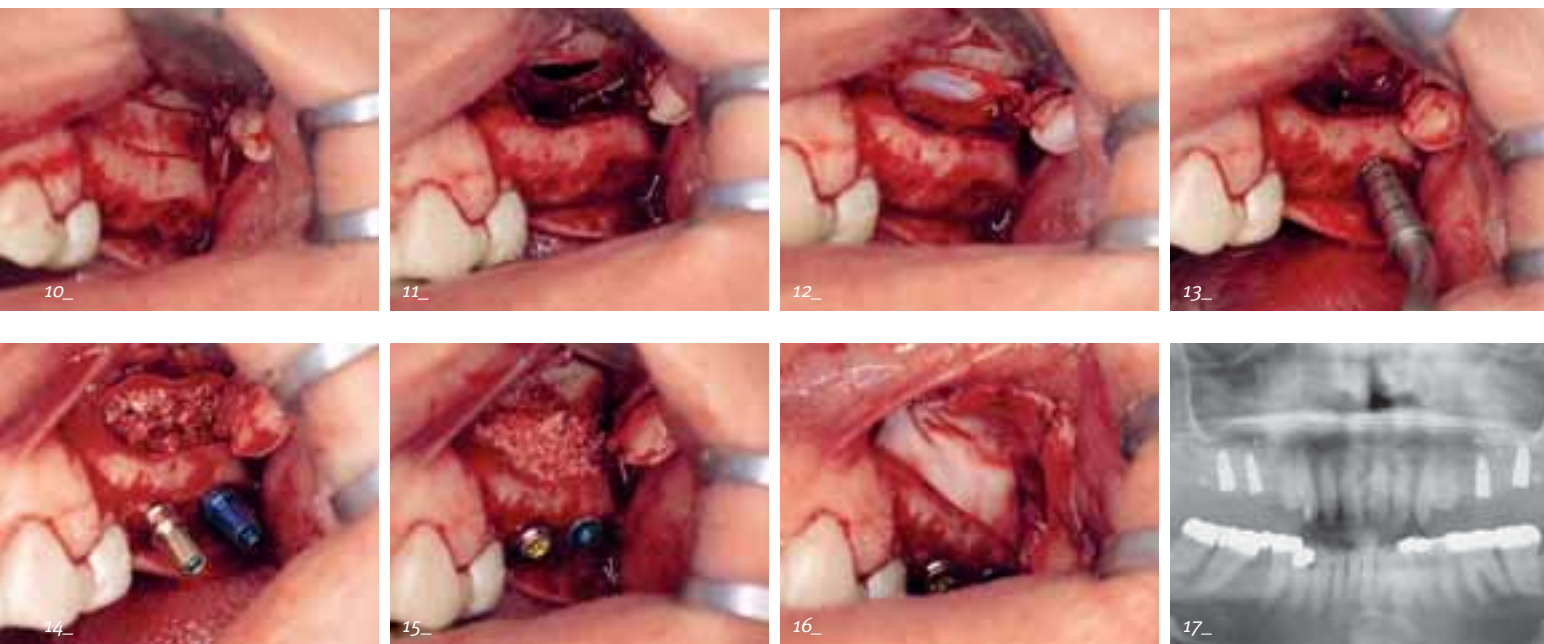
- 10_ The bony lid was prepared with piezo surgery.
 11_ In spite of minimally invasive preparation technique the sinus endothelium was ruptured.
 12_ The rupture was covered with a membrane.
 13_ The implant site was prepared by condensing the bone.
 14_ The inserted Xive implants (length 11 mm)
 15, 16_ The filled bone defect was covered by a membrane, which was fixed with Frios tacks.
 17_ The result after nine months of submerged healing
 18, 19_ The change in the occlusal height and occlusion also required a new restoration in the mandible.
 20, 21_ The finished denture before delivery
 22, 23, 24, 25_ The patient was very satisfied with the appearance and function of the fixed denture.

The surgical procedure turned out to be extremely difficult. The bony lid for access to the maxillary sinus was prepared with piezo technology (Fig. 10). In spite of this minimally invasive procedure, the sinus endothelium on the left side was

ruptured at the top margin (Fig. 11) because of its virtually spider-web-like consistency. The defect was covered with a membrane (Fig. 12) to prevent the augmentation material from migrating into the sinus.

After pilot drilling, the implant site was prepared by bone condensing exclusively because of the poor bone quality (D IV) (Fig. 13). Two 11 mm long Xive S implants diameter 3.8 mm and 4.5 mm were placed (Fig. 14). Because of the condensing thread design and the hydrophilic Friadent plus surface, which promotes cell growth, we expected good osseointegration even under these unfavorable conditions.

I used standard bovine bone substitution material and bone chips from the patient for the augmentation (Fig. 15). The sinus access was closed with a membrane (Fig. 16) fixed with Frios tacks (Fig. 17). The preparation of the sinus on the right side was the exact mirror image of the left side with the same type of weak bone and the extremely thin sinus endothelium. An extensive rupture also occurred here and was repaired as described above.
